Lower Silvermine River Historic Flood Protection Measures

*Information from the book by
Malcolm M. Cobern, 1984:
Story of the Fish Hoek Valley;
From the beginning of time.*

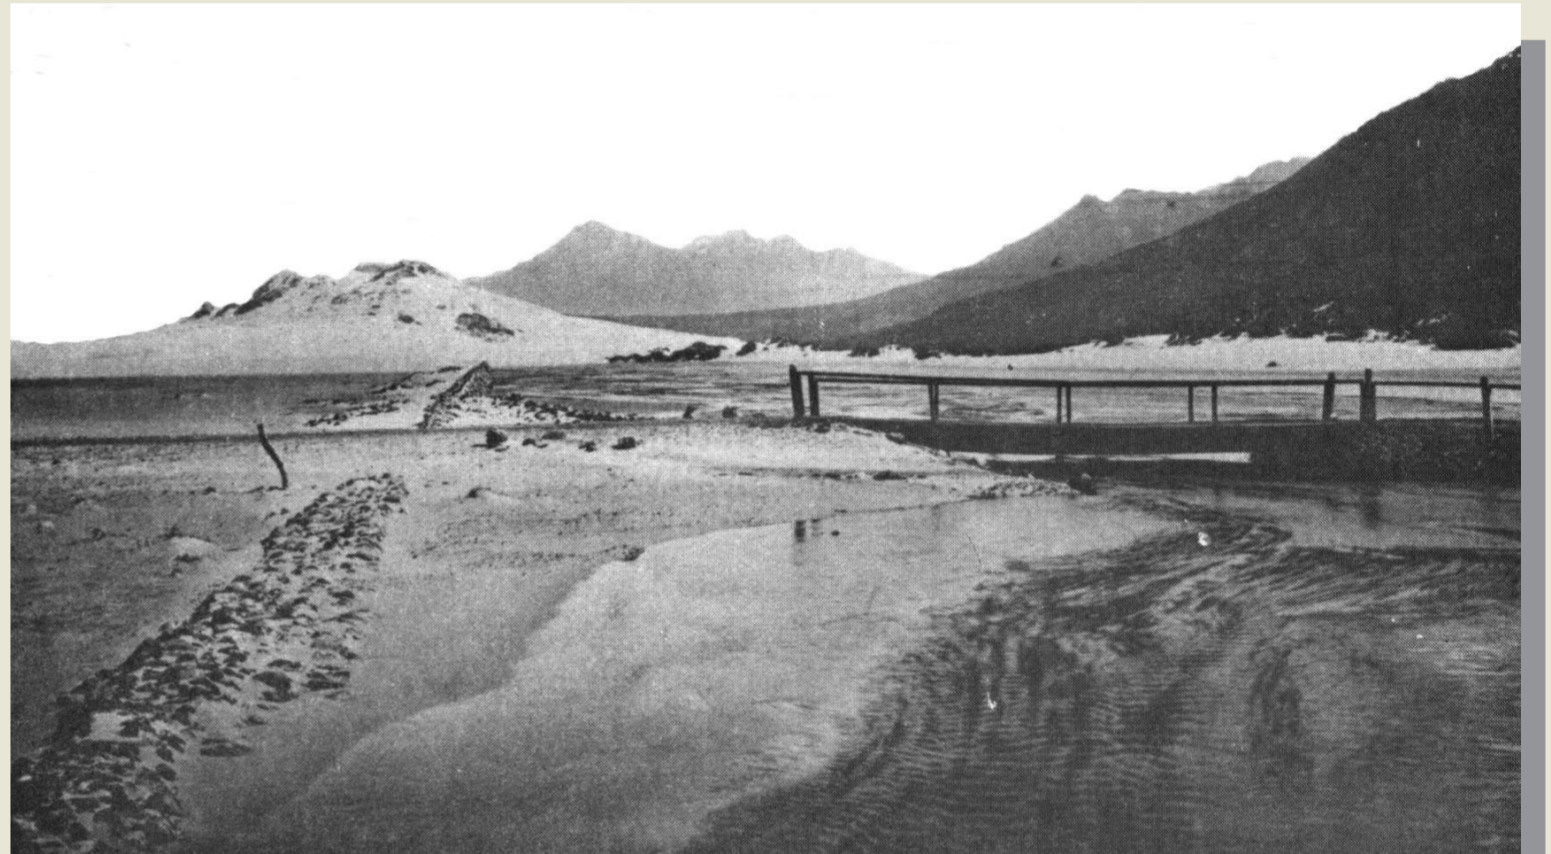
In an effort to try and prevent the Silvermine stream from straying from its normal path, when in flood, the authorities about 1925 built this iron and stone retaining wall about 50 feet from the stream. Although it no longer serves its purpose, its remains are still there. This is a different one from that built by the Railway at a much earlier date.

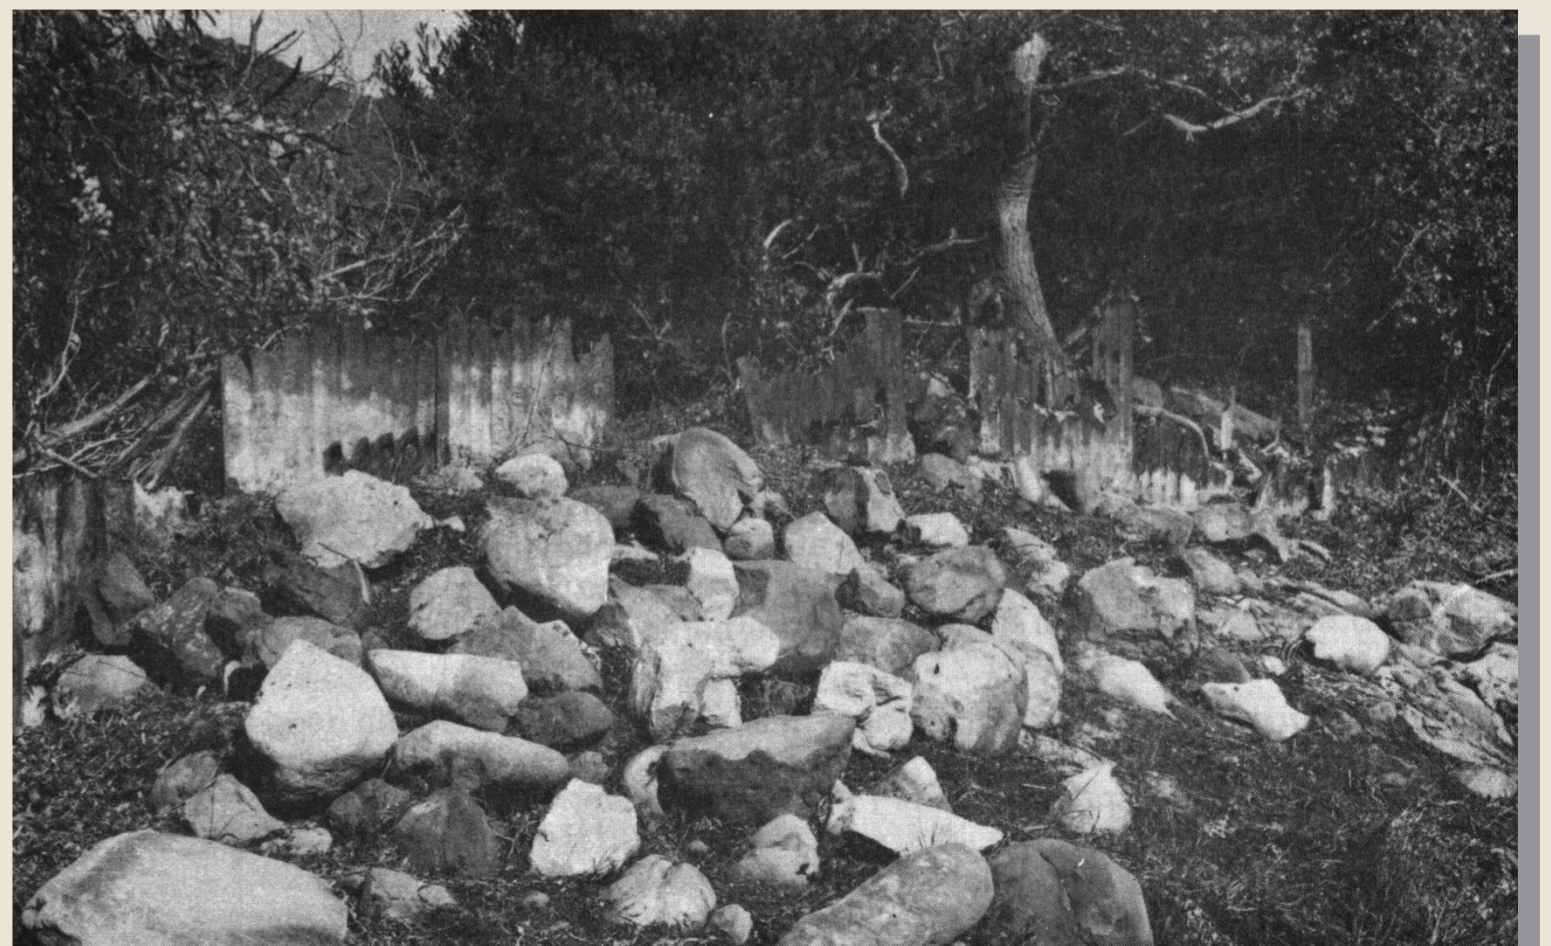
This wall was strengthened later with corrugated iron sheets, and in places by redundant water tanks filled with sand. Remains of the wall are still visible.
